Sedimentation dynamics of soil particles in sylvopastoral half-moons on restored plateaus in the Ouallam department (Niger)

Abstract— The present study was conducted on the Tondibiya and Satara plateaus, in the Ouallam department (western Niger). The objective is to study the sedimentation dynamics of soil particles deposited in sylvopastoral half-moons of different years (2014, 2016 and 2018). The assessment of sedimentation was done in selected half-moons following a survey on transects. It involved the determination of the thickness of the sedimented horizon, the measurement of the permeability by the single ring infiltrometer and the granulometric analysis in the laboratory. The results obtained showed that the thickness of the sedimented horizon varies according to age and is 14.15, 17.33 and 19.37 cm in the 3, 5 and 7 year old half-moons respectively. Water infiltration was optimised by sedimentation. It was recorded 70 minutes to be constant in the 7-year half-moon and 40 minutes in the 3-year half-moon. The granulometric analysis of the sedimented particles shows their dominance by sands (77.73%). These different results show that the sylvopastoral half-moon is effective i

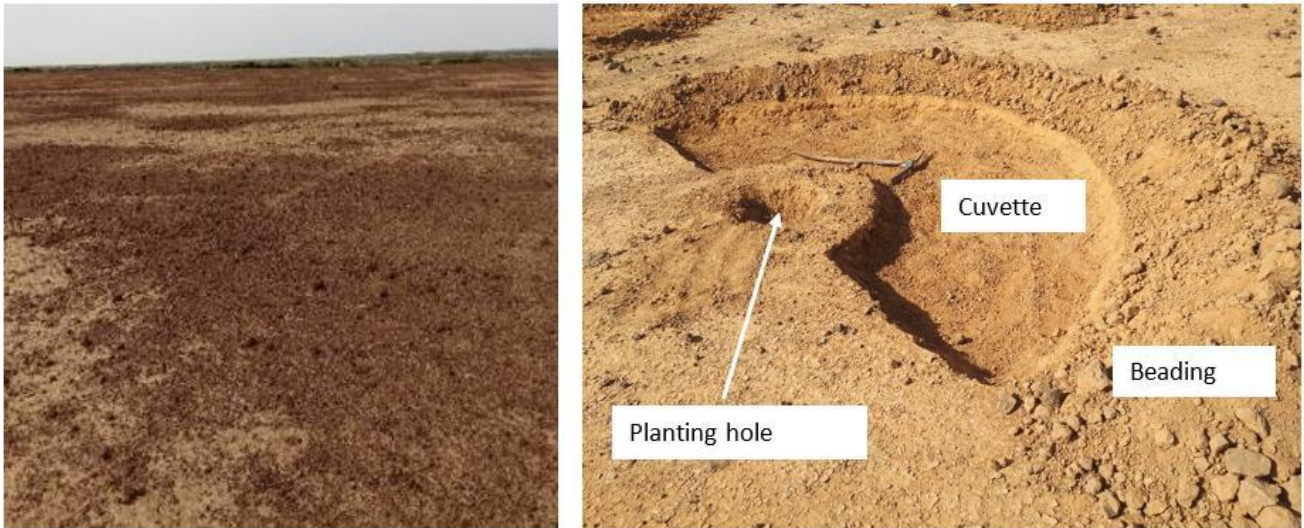
Photo 1: a: View of an undeveloped site; b: Compartment of a completed half-moon

The silvopastoral half-moon, the subject of this study, has the characteristics presented in Table 1. Photo 1 illustrates a half-moon.

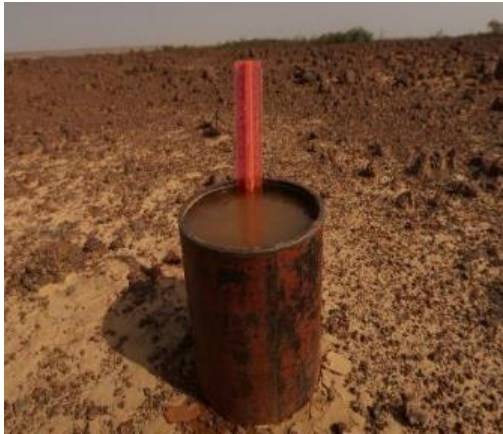
Photo 3: Installation of the infiltrometer on an unfinished control

The infiltration test was carried out in the pit of the structure and on a bare area without vegetation representing the control (Photo 3). The permeability allows the sedimented soil to be compared to the encrusted control, as insufficient water infiltration into the soil is a key factor in land degradation or fodder production on pastureland.

The 20 cm diameter single ring infiltrometer was the equipment used to measure water permeability. The activity consisted of installing the infiltrometer and quantifying the infiltrated water depths. The infiltrometer was sunk about 5 cm into the ground to prevent water from leaking onto the ground surface during the test. It is then filled with potable water to a height (H) and allowed to infiltrate for a timed period. At the end of the time, a height (Hf) is obtained from which the infiltrated height (Hi) is obtained by formula (3). The operation is repeated by filling the infiltrometer again to the height H. The activity is thus continued repeatedly until a constant infiltration height is obtained (same Hi value three times in a row). The number of repetitions of the operations during

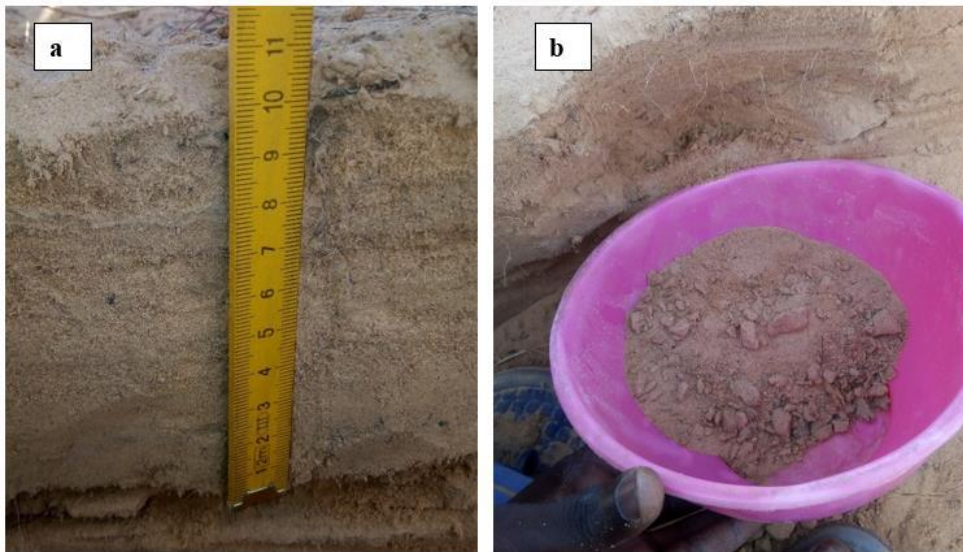
Photo 4: a: Core measurement, b: Soil sampling

The physical analysis of the soil particles concerned the first 10 cm in the basin and an undeveloped area representing the control. Sampling was carried out across a crop profile (Photo 4).

A composite sample was taken per transect. Soil samples were analysed in the soil laboratory of the Faculty of Agronomy of Abdou Moumouni University of Niamey. The Robinson Pipette method was used for the particle size analysis. The textural elements concerned are clays, silts and sands. The textural class was determined using the textural triangle.

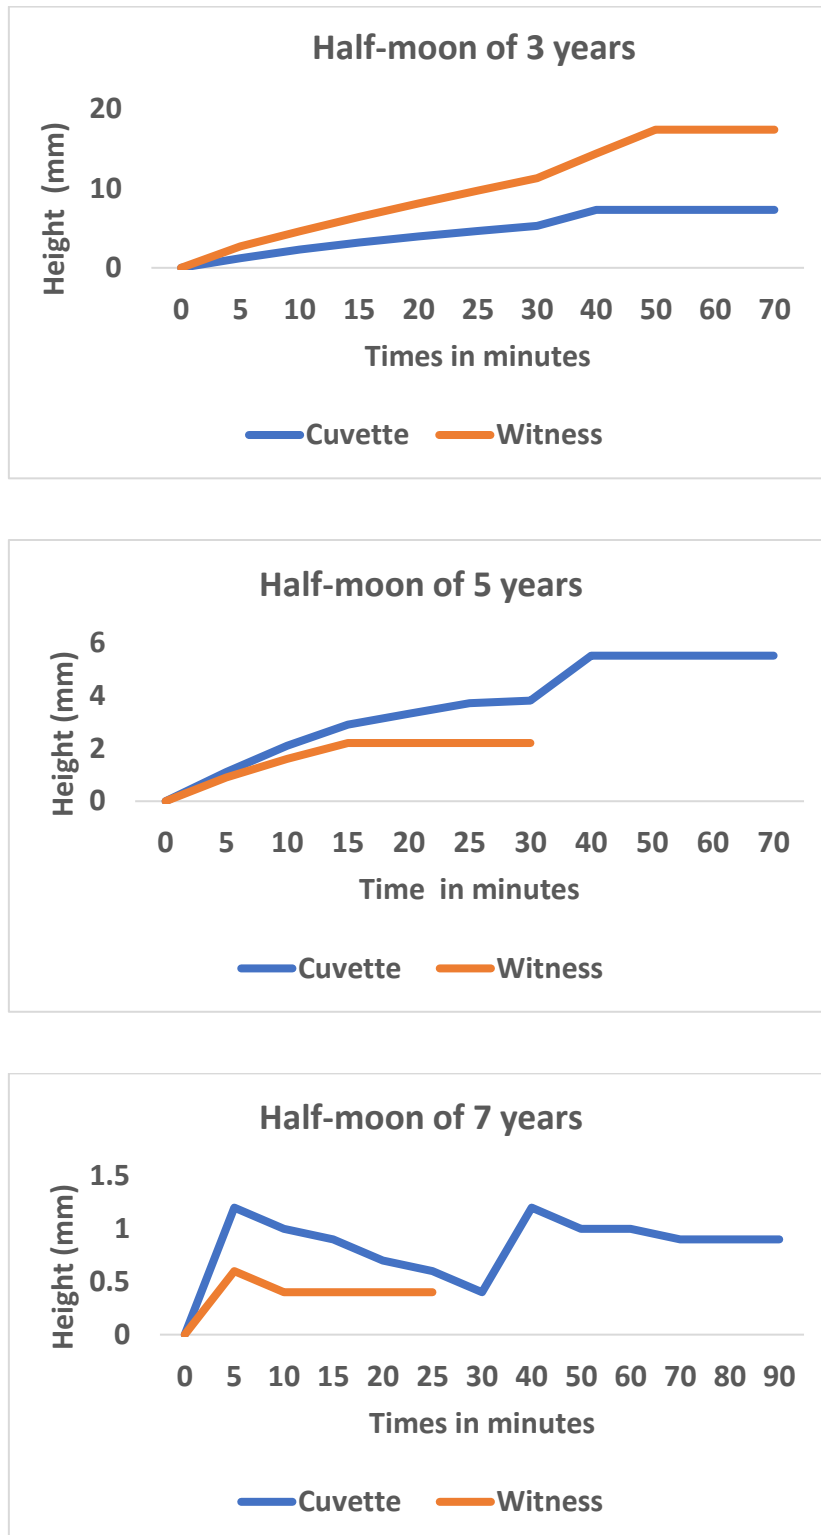
Fig. 3: Evolution of water infiltration in the half-moon

It can be seen that the volume infiltrated and the time taken to obtain constant infiltration on the sedimented soil are greater than those of the control, with the exception of the 3 year old structure. The permeability study shows that infiltration and its speed increase with the age of the structure (Fig. 3 and 4).

It can be seen that infiltration has been improved by the half-moon. The better infiltration recorded on the 3 year old control site is explained by the fact that the upper soil horizon has more pores than the sedimented layer in the half-moon.
