# Inventorization of Abandoned Mines and quarry Pits in Taraba State, Nigeria

Ahmed, Y.M. and Oruonye, E.D.

Department of Geography, Taraba State University, P.M.B. 1167, Jalingo, Taraba State

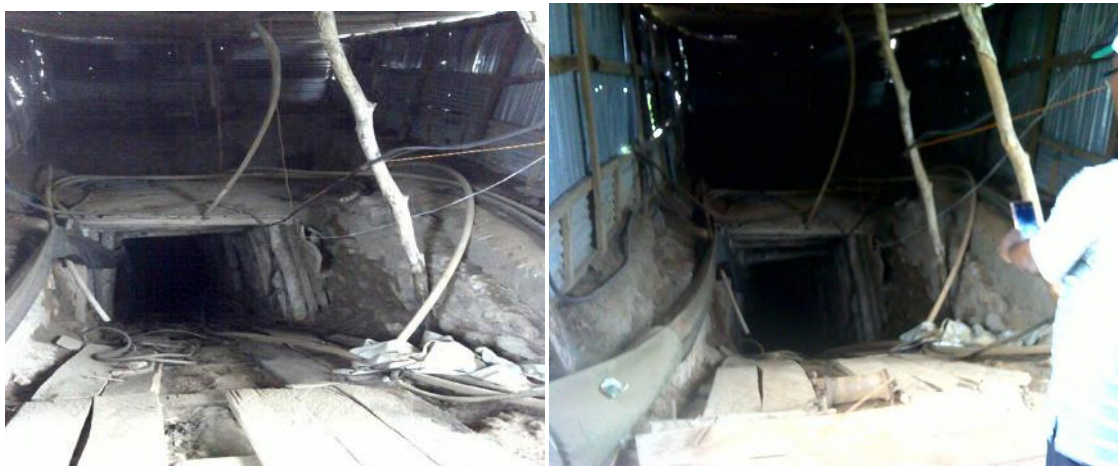
*Plate.1: Underground mining Tunnel at Jukun Village in Karim Lamido LGA*

Findings of the study shows that most of the abandoned mine sites in the state are surface mining with open pits/cast. There are only 2 underground mining tunnels at Jukun and Ameche communities in Karim Lamido LGA (Plate 1).
